# Clay Biggings

OF THE TAY  
LANDSCAPE **2**

*our survey of  
147 surviving  
earth buildings*

# Volume 2: Earth Building Survey

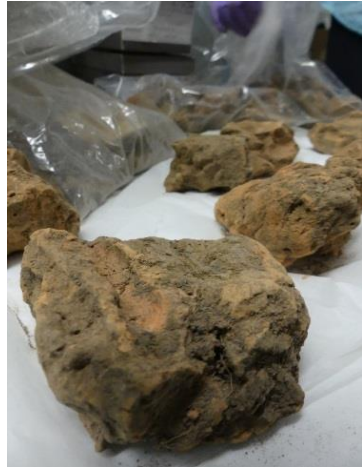
**ASSESSMENT:** The legionary fortress at Carpow was a massive structure comprising many substantial buildings within an enclosure of ditches and walls. The 11 hectare site was home to about 3,000 men. The site was systematically destroyed by the Romans at the end of their occupation around 220 CE and no structures remain above ground. The site has been investigated archaeologically several times and identified the use of clay, both fired and unfired. No clay mortared masonry was found, but there were turf ramparts and large quantities of wattle and daub, as well as use for floors and drainage. Daub fragments are in the custody of McManus Galleries Dundee.

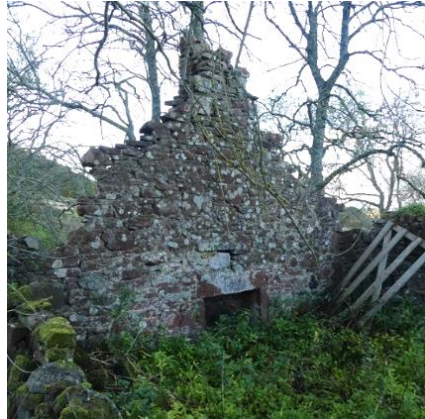
Address:..... **BURNSIDE COTTAGE & SMITHY**  
Pitkeathly Mains

**ASSESSMENT:** There are substantial remains of 2 buildings with clay bonded random rubble walls in poor condition. Shown roofed on 1866 OS maps, they were gone by the 1920 map. Reference to thatch. The site is located not far from a map reference for Clayfolds. There was a planning application 2012 for redevelopment. Surveyed by LD, SW & TM.

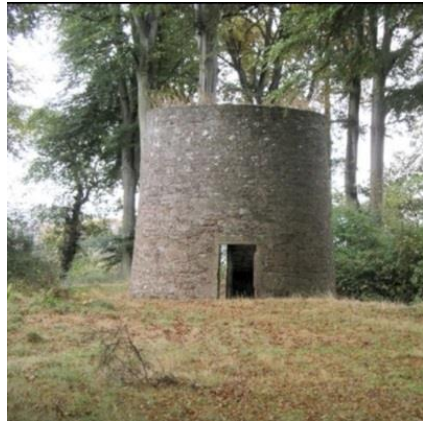
**ASSESSMENT:** This is a rare typological example of a windmill built from mud mortared masonry, which has lost its roof and mechanism, but the masonry is in reasonable condition. LD & SW surveyed on 2017.11.19. Photo © HES.

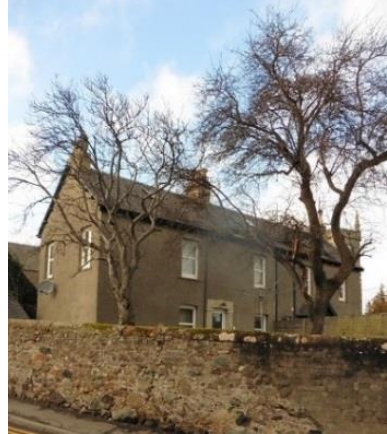
**ASSESSMENT:** This is thought to be a typical example of a 19<sup>th</sup> century mudwall 2 storey semi-detached house. Mudwall was not seen on this building, but in 2015 a patch fell of the gable to the abutting building and revealed mudwall beneath (TM). Apart from cement render the building seems in good condition.

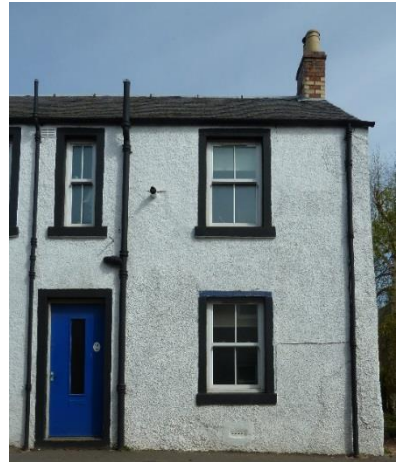
**ASSESSMENT:** This is a typical mudwall house with notable batter to the wall. It is cement rendered, but otherwise appears in fair condition.

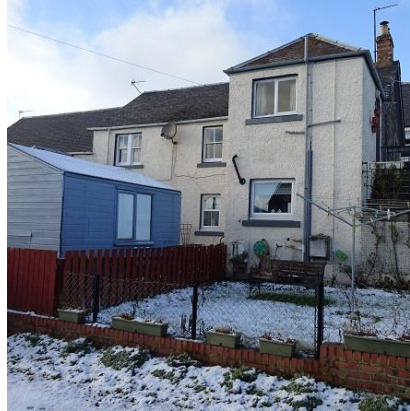
**ASSESSMENT:** This is a typical mudwall house with modern extension. The main walls front and back are clay. It is cement rendered, but otherwise appears in fair condition. It appears on the 1st edition OS map of 1854.

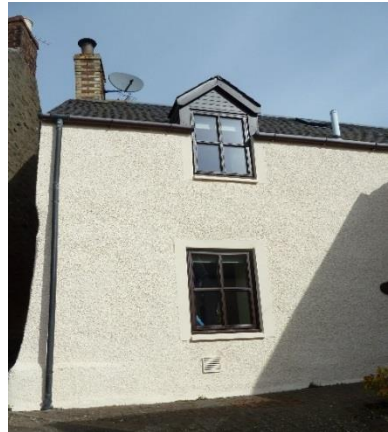
**ASSESSMENT:** This is thought to be a mudwall house, with sign of historic alterations. It is cement rendered, but otherwise appears in fair condition.

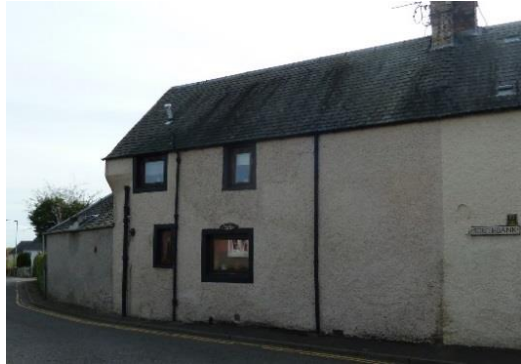
**ASSESSMENT:** This is thought to be a mudwall house, with sign of historic alterations. It is cement rendered, but otherwise appears in fair condition.

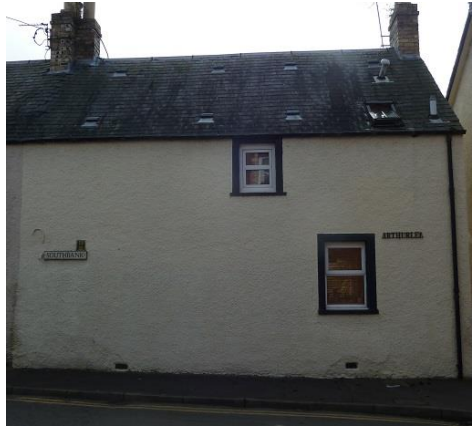
**ASSESSMENT:** This is thought to be a mudwall house, with sign of historic alterations. It is cement rendered, but otherwise appears in fair condition.

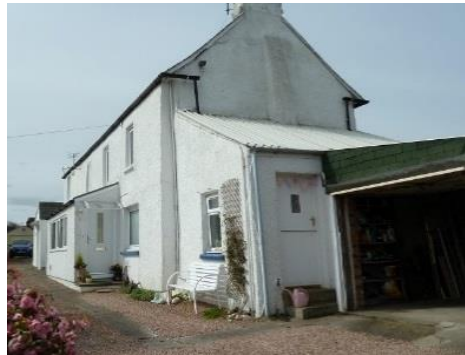
**ASSESSMENT:** Owners confirmed that all walls are mudwall 1.5 - 2ft thick. There was a serious house fire 10 years ago which melted a water pipe causing flooding of entire building but the clay walls absorbed most of it and dehumidifiers dried it out. Formerly thatched. Old family home and former weaver's cottage. Old title deeds on velum (now lost). Other than the cement render, the house looks in good condition.

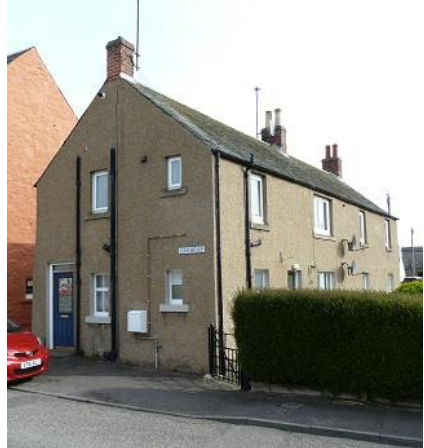
**ASSESSMENT:** A late example of a mudwall town house, with later window alterations. Cement render appears in reasonable condition. The single flue chimney does not match the others on the building.

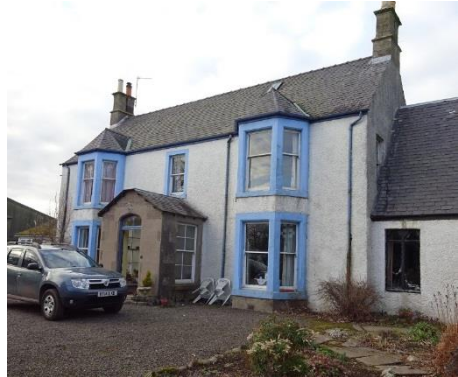
**ASSESSMENT:** Clay mortared masonry was found in an exposed internal store room wall. The owner reports that 2 types of clay are found close by, the marine clay is greyer than the boulder clay from Ninetree brae. The Listing description states it has clay & horsehair, possibly meaning plaster, but none was identified when visited by LD & TM.
