# Clay Biggings

OF THE TAY  
LANDSCAPE **2**

*our survey of  
147 surviving  
earth buildings*

# Volume 2: Earth Building Survey

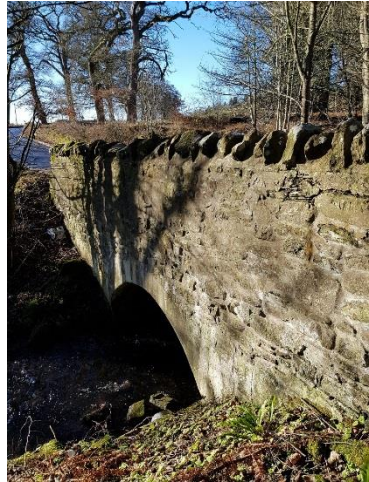
**ASSESSMENT:** LD & SW surveyed the bridge and identified clay mortar on 19.11.2017. The masonry also has cement pointing and it is assumed it was originally lime pointed. Photograph courtesy of Linda Dunwell.

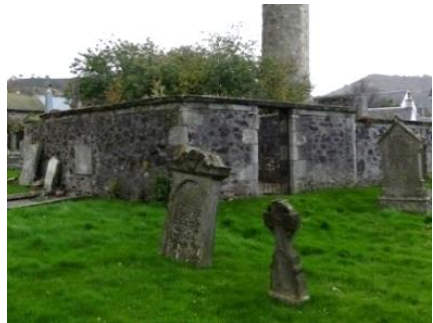
**ASSESSMENT:** This rectilinear enclosure has clay mortar, possibly with lime inclusion. The original lime pointing has been replaced with cement, which is failing. At low level there is decay, with stones falling out. Site visited by TM 01.11.2017. Many of the graveyard enclosure walls are similarly mortared, but have not been included in the survey record.

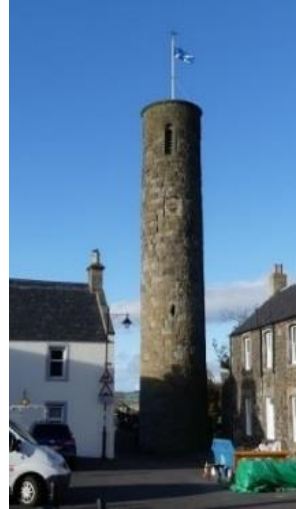
**ASSESSMENT:** This ancient tower is a rare example in Scotland of a round tower more typically found in Ireland. It is thought to have been associated with the Culdee monastery, of which nothing else survives. Indeed no other buildings survive in Abernethy from before the 18<sup>th</sup> century. Clay mortar was found in an open joint near the base of the tower and recent mortar analysis higher up found a mix of clay and lime with sand. Site visited by TM 01.11.2017.

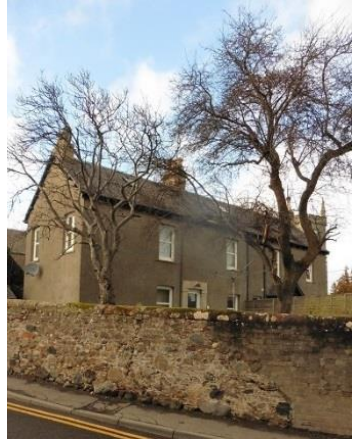
**ASSESSMENT:** This is thought to be a typical example of a 19<sup>th</sup> century mudwall 2 storey semi-detached house. In 2015 a patch fell of the gable and revealed mudwall beneath (TM). Apart from cement render the building seems in good condition.

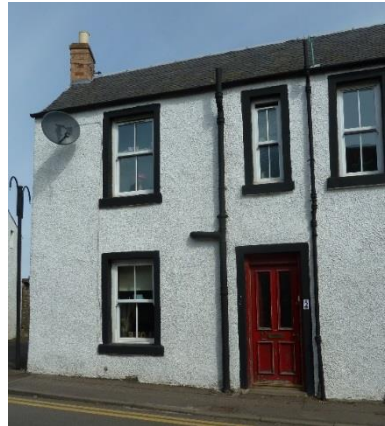
**ASSESSMENT:** This is a typical mudwall house. It is cement rendered, but otherwise appears in fair condition.

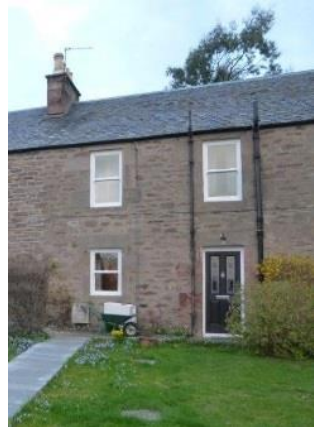
**ASSESSMENT:** This semi-detached house has cement rendered mudwall to the gable and rear external walls, with the front elevation faced in stone, presumably mudwall behind. Mudwall was confirmed on the rear wall where the cement render is cracked and boss. (TM).

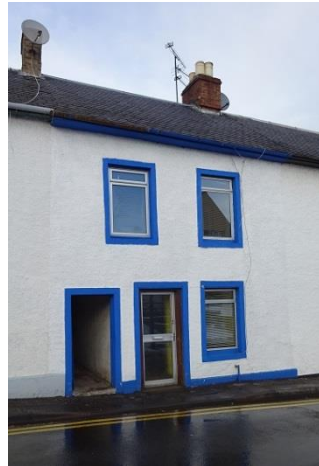
**ASSESSMENT:** The owner confirmed that this building is mudwall and it appears a typical town house, dating from the later period. Cement render in decent condition.

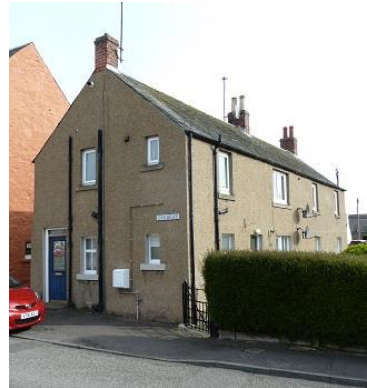
**ASSESSMENT:** A late example of a mudwall town house, with later window alterations. Cement render appears in reasonable condition.

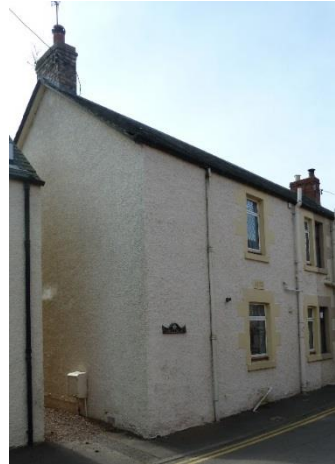
**ASSESSMENT:** The owner reported that originally there was a clay wall at the front. The house burnt down and after, it was rebuilt. The only remaining clay wall is in the downstairs kitchen. The next door house was completely rebuilt. A number of properties in Errol have suffered fires.

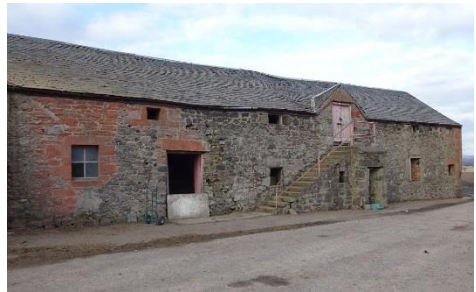
**ASSESSMENT:** Clay mortared masonry was found on east gable of barn and in the wall of the outbuilding holding the tank. Clay/lime mortar was found in the wall and remnants of the building next to the new shed. The owner reports that 2 types of clay are found close by the marine clay is greyer than the boulder clay from Ninetree brae.

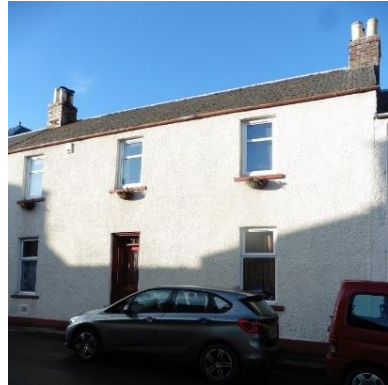
**ASSESSMENT** The owner said it had been rebuilt in 1870, thought to be older. Extended. No visible damp. No foundations. Two walls internally are clay.

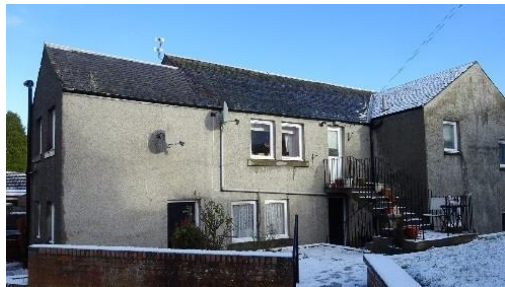
**CONDITION ASSESSMENT:** This building has been much altered and is now divided into 4 flats. Clay was identified by TM in a hole in the cement render on the north side.

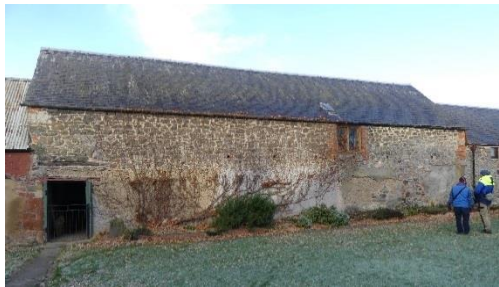
**ASSESSMENT:** This outbuilding contains mudwall in number of external and internal walls, alongside later masonry alterations. Repairs to the mudwall were undertaken in 2016 repairs as part of the TLP. There are timber lintols and cement render in poor condition.

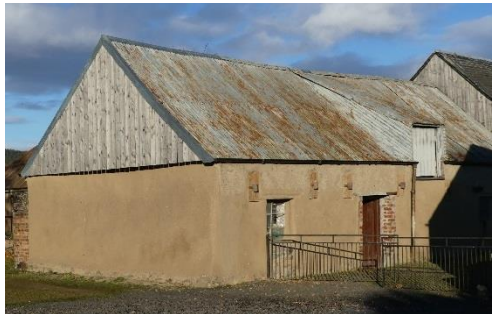
**ASSESSMENT:** This build appears on the 1<sup>st</sup> edition O.S. Map and shows alterations, including increasing the wall height which suggest it may have originally be a cottage. Extensive repairs were undertaken as part of the TLP. Remnants of turf roof, internal clay plaster and external lime harl were found. The repairs included a new external earth render.

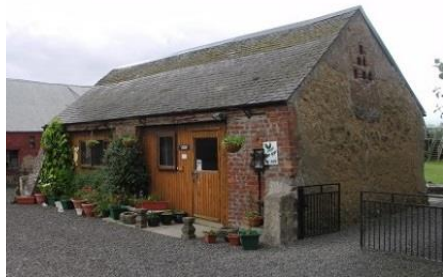
**ASSESSMENT:** This is named as Former Cart shed on the listing description and incorporates a pigeon loft, with entry on the south gable. The silt-rich mudwall is visible and in better condition on the north gable, than on the south where there is moss growth that does not appear to be causing significant damage. Evidence of significant alterations in brick. No internal inspection.

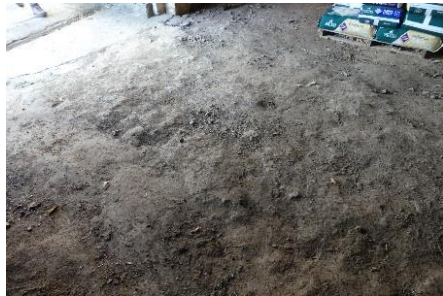
**ASSESSMENT:** This is one of the few surviving examples of clay floor which were found during the survey. It is a working farm floor, regularly trafficked and the owner reports it works well. The building is thought to have clay mortared masonry as well, but not mudwall.

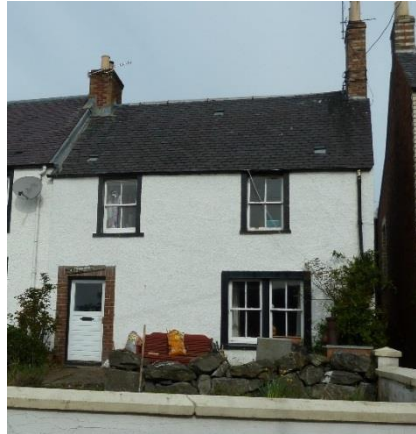
**ASSESSMENT:** The owner describes all the walls as clay, 600mm thick. The building was subject to a fire in the past and 'old tree trunks' are reported to have been found during renovation. Mudwall can be seen in the airing and electricity cupboard.

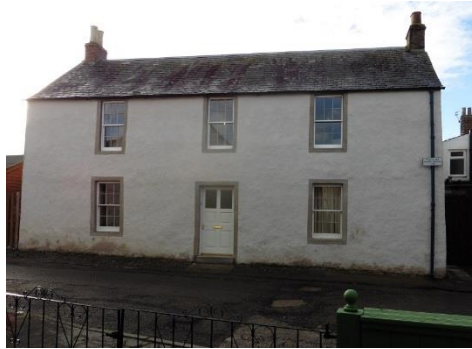
**ASSESSMENT:** Gray House is a mudwall house, with numerous alterations, mainly in clay mortared masonry and brick. It underwent extensive repairs as part of the TLP, and this is recorded in a HES Good Repair Guide. Remnants of broom thatch in the roof space were found although, like all Errol buildings, it is now slated. The south gable was faced with concrete block after demolition of the neighbouring building, which was semi-detached, leaving this one alone.

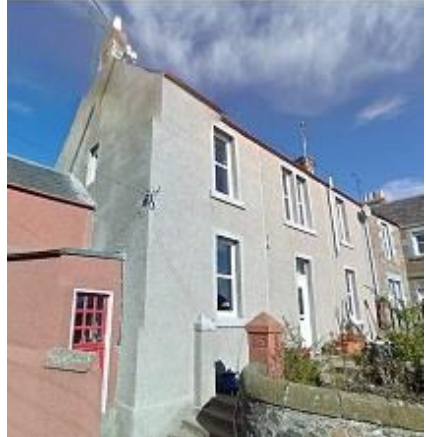
**ASSESSMENT:** This was identified as mudwall in 2012, but no details have been verified. There are cracks in the cement render.

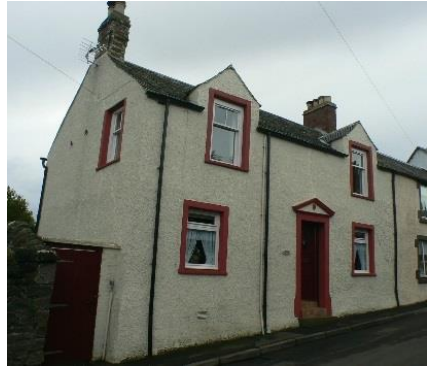
**ASSESSMENT:** This house shows typical characteristics of mudwall house, with a battered base, but all concealed behind cement render, which shows some cracks.

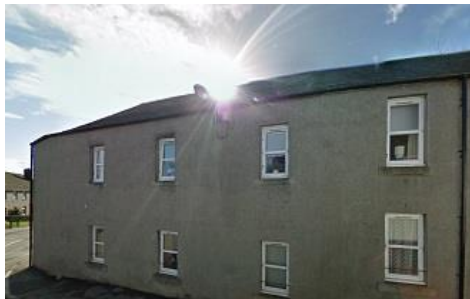
**ASSESSMENT:** The building is shown on 1<sup>st</sup> OS 1854 and appears to be mudwall, much altered and cement rendered. An adjacent building showed clay through a crack.

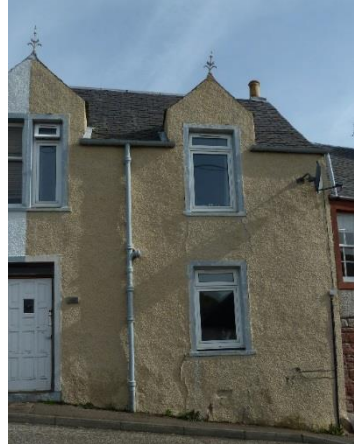
**ASSESSMENT:** This is a typical mudwall, semi-detached house, where mudwall was visible during render repairs to the rear wall of the neighbouring building, Riverview. The render is cement.

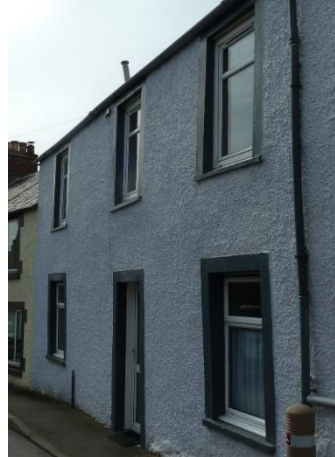
**ASSESSMENT:** The owner confirmed clay construction and it appears a typical mudwall building in good condition, apart from cement render.

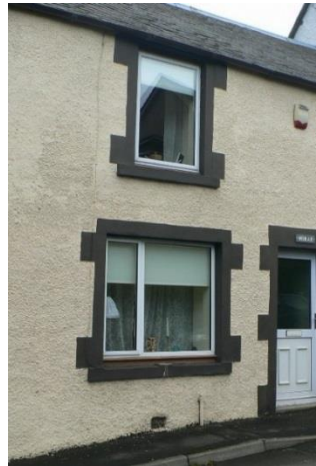
**ASSESSMENT:** The main body of the house is mudwall, which has been confirmed by the owner. It has a stone foundation course. First noted on valuation rolls in 1854.

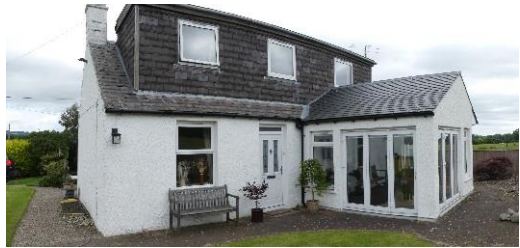
**ASSESSMENT:** This cottage has had significant modern alterations, but mudwall wallheads were seen from the attic space. There are minor cracks in the cement render and TM gave the owner maintenance advice.

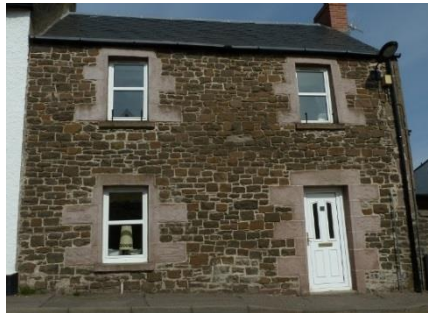
**CONDITION ASSESSMENT:** This was formerly two properties, merged when it was renovated in 2007. The walls are 2ft thick with a stone front façade, cement pointed, and cement rendered side and rear. The owner found mudwall in the attic. A bit of damp is reported near windows. The uninsulated plasterboard linings are reported to be 1ft away from the mudwall which 'is crumbly'.

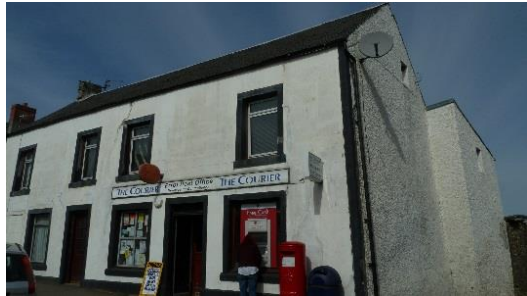
**ASSESSMENT:** The building is mudwall with cement render, which is cracked in places. The east end ground floor is the post office, believed to have formerly housed a cobbler's and/or a saddlers. The original structure is of mudwall construction built off a boulder base, later raised in brick. (see Viv Whyte A study of historic earth structures in the Carse of Gowrie, 2010, p118-124).

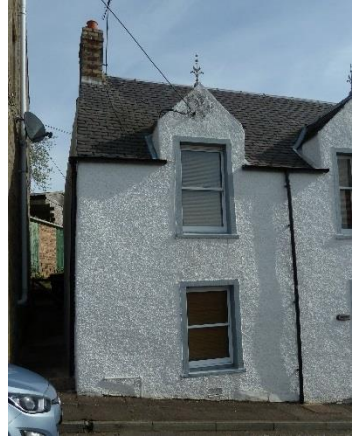
**ASSESSMENT:** The rear wall was seen to be mudwall with cement render when under repair in 2016.

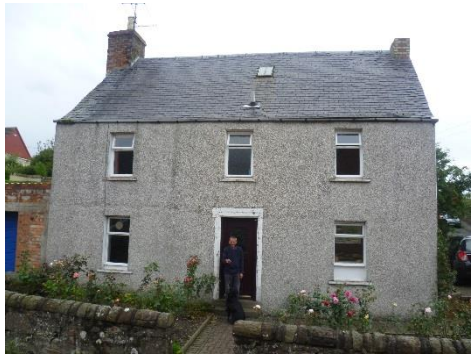
**ASSESSMENT:** The house is present on the first edition OS Map 1860. All walls are mudwall, excluding the recent extension, with a brick built chimney stack. Lime render was removed in 1970 and replaced with wire lath and sky marble chip cement roughcast. Title deeds to the property grant a feu duty with rights to cut reeds from the Tay and dig clay, so it originally must have been thatched.

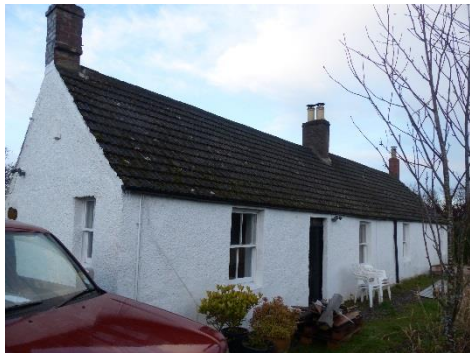
**ASSESSMENT:** Traditional 18th century mudwall cottage. Single storey, 5-bay altered from 6, this was originally a pair of cottages united into 1. On 1<sup>st</sup> edition OS map. The cement render is badly cracked in places and there is signs of damp problems on the north west wall. TM & BL visited in Dec 2016 and gave owners maintenance advice.

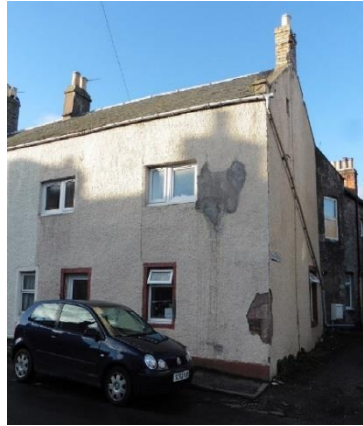
**ASSESSMENT:** This is a mudwall building with a clay floor under concrete. The external cracked cement render was being removed and expected to be lime harled.

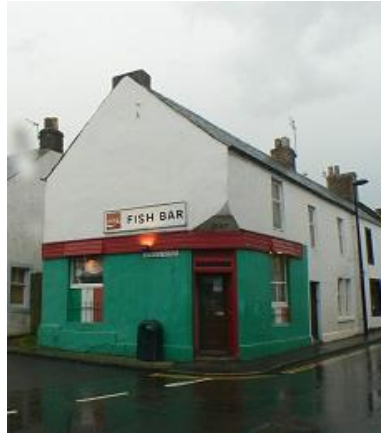
**ASSESSMENT:** The chip shop an unusual mudwall building with a corner doorway and corbel over. The cement rendered is cracked.

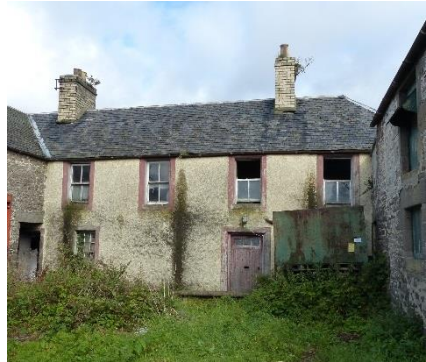
**ASSESSMENT:** The Horn Farmhouse is an unusual mudwall building, with a low ground storey and generous first floor. Most of the walls are cement rendered, but the west wall is stone faced. It is recorded as being designed or altered by a Dundee Architect in the 19<sup>th</sup> century. A Latin inscription above the entrance door is translated as ‘a mud house is my defence’. The building has been disused for several decades and poorly maintained. Leaking rones led to the collapse of a section of mudwall, which was repaired through the TLP. It remains unused, however and at risk form further decay.

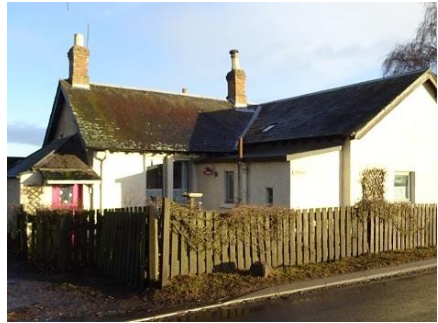
**ASSESSMENT:** The current owner is unsure if it is mudwall; but was once told the cottage was built from the spoils of the gully making. It is present on OS 1ed 1843 and a plan of the cottage from the 1940's shows it was once two dwellings. Parts look to have stone foundations. The 1940's work included concrete extensions with flat roofs & metal windows.

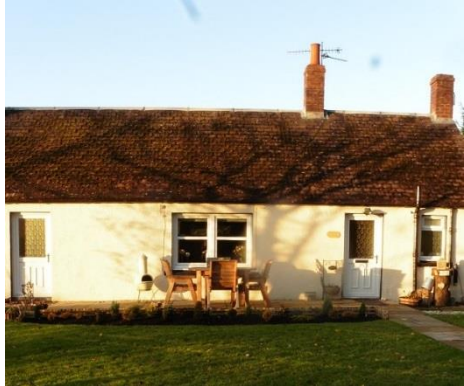
**ASSESSMENT:** This cottage is assumed to be mudwall as the adjacent Bee Cottage is confirmed mudwall. On first edition Ordnance Survey map.

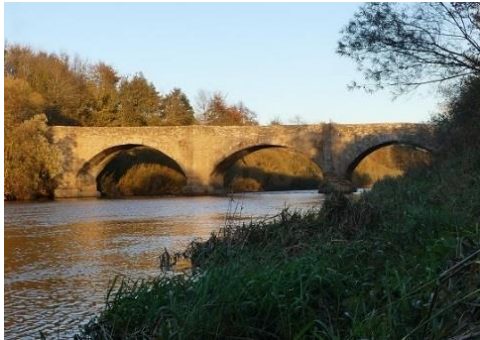
**ASSESSMENT:** The 18<sup>th</sup> C. bridge is single carriageway over 3 arches. TM & LD found clay/lime mortar in the parapet, behind modern cement pointing in poor condition.

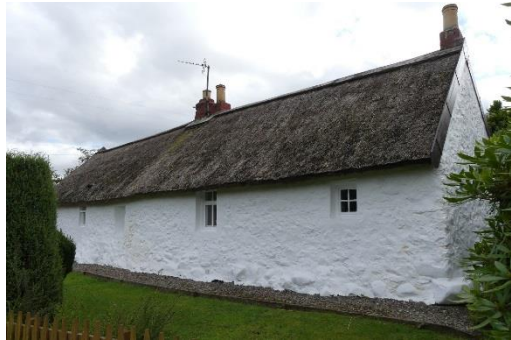
**ASSESSMENT** Single storey thatched cottage, highly likely to be clay mortared masonry, given age, location and precedent. Dark stains indicate clay mortar

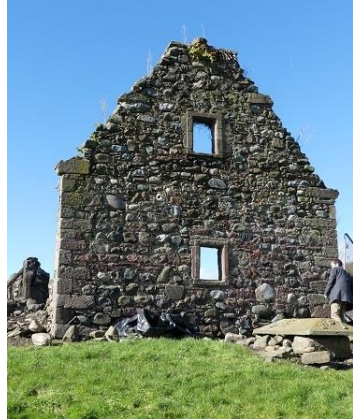
**ASSESSMENT:** The remains of the pre-Reformation parish church, which was abandoned in the early 17th century. It is 20m by 6.4m with walls 0.8m thick of random coursed rubble with freestone quoins and dressings. The east gable survives to its full height and other walls to varying height. Original sections of wall are clay mortared, with remnants of internal lime plaster, and later alterations in lime. The ruin was repaired by the TLP project and comprehensively repointed in lime, with new interpretation panels.

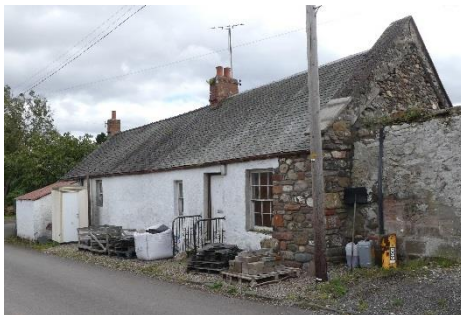
**ASSESSMENT:** Good example pf clay mortared masonry in decay with large cracks.  
Previously thatched, single storey harled and slated.

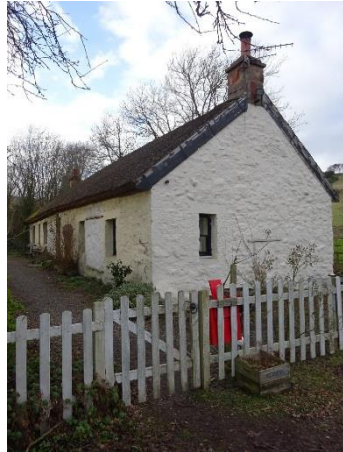
**ASSESSMENT** 18<sup>th</sup> century pair of cottages, united into one. The cottages have a continuous thatched roof, thatched in reed. Single storey whitewashed rubble. Wallhead slopes with ground. Brick chimneys. Highly likely to be clay mortared masonry, given age, location and precedent

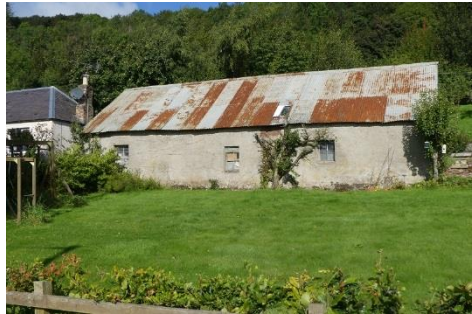
**ASSESSMENT:** This important building shows clear evidence of having been a row of (3?) cottages, with the east one demolished apart from the wall base, and the other two combined to form an outbuilding. Much original construction survives including clay mortared masonry with mudwall above showing that mudwall was used to alter and improve masonry buildings. Clay plaster with a lime top coat and some historic graffiti can also be seen. Planning permission for conversion granted but not enacted. There was a similar building to the west, damaged by fire and replaced in the 20<sup>th</sup> C.

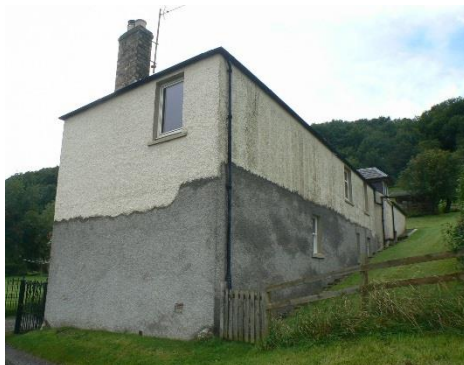
**ASSESSMENT:** The owners confirmed that the ground storey is mudwall, with a clear boulder base, while the upper storey was extended in brick. The building, possibly originally 2 cottages, appears on the 1<sup>st</sup> edition OS map 1843-82. The Edinburgh Advertiser newspaper of 1819 reported..."the soil of this farm is strong clay". TM & LD inspected. Modern cement render in good condition.

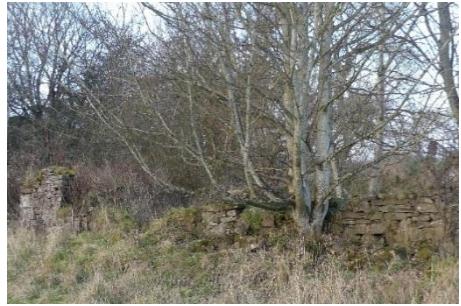
**ASSESSMENT:** Building 9 comprises reasonably well-defined remains of rectilinear earth mortared masonry walls.

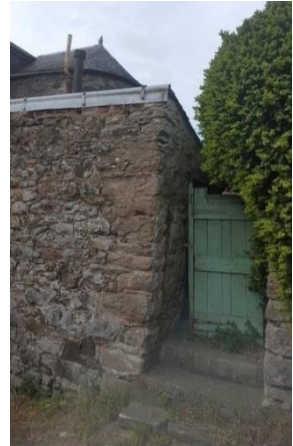
**ASSESSMENT:** Clay mortar was identified by LD during field work. It may indicate clay mortar in some of the more substantial 19<sup>th</sup> C buildings which could not be examined closely.

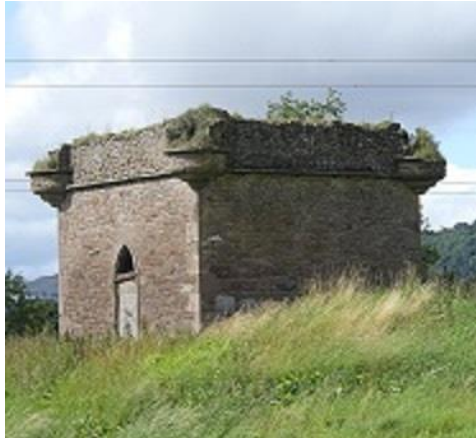
**ASSESSMENT:** TM & LD found mud mortar with hot lime inclusions. The mortar has a lovely red/brown colour and appears in excellent condition, despite the absence of the roof and corbelled corner turrets. Traces of a lime harl remain. This derelict doo'cot masonry was in significantly better condition than the others examined and this attributed to the quality of the mortar.

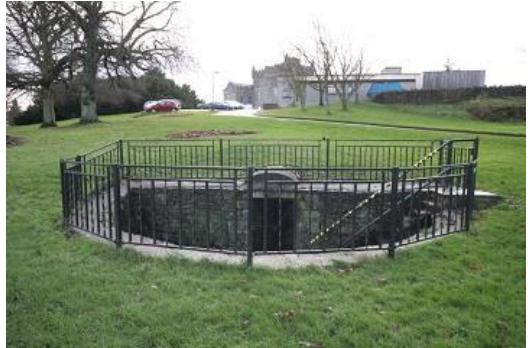
**CONDITION ASSESSMENT** A very early intact example of an estate icehouse, situated to the northeast of the castle. There is a semi-circular forecourt set into the sloping ground, with rubble retaining walls and a flight of steps leading down to the entrance. This is surrounded by later metal railings. The interior is brick with a passage leading to the bottle-shape ice chamber. TM & LD identified clay mortar behind lime mortar on the entrance wall. How much clay mortar is used in the main construction could not be determined.

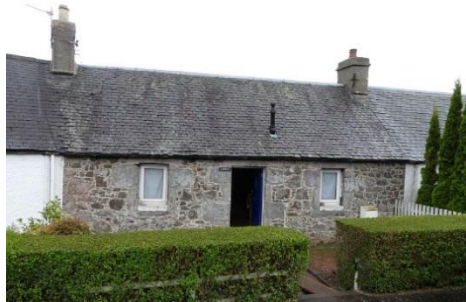
**ASSESSMENT:** TM & LD confirmed mud mortar 2017.08.25. Red clay mortar found in all internal walls. Clay subsoil in garden looks very similar. The owners are currently renovating, including pointing walls with lime. The concrete floor has been lifted revealing a clay floor beneath. This is one of a curved row of 4 cottages, numbers 76-82, assumed originally identical.

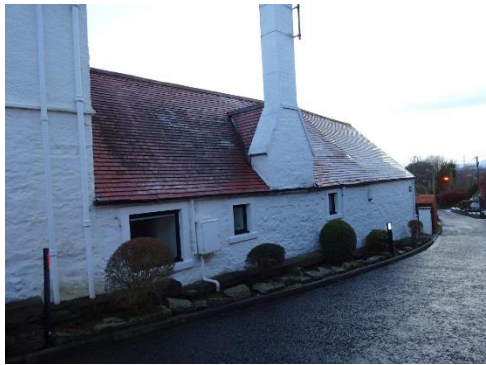
**ASSESSMENT:** This building is on 1<sup>st</sup> edition OS map. Highly likely to be clay mortared based on date and form.

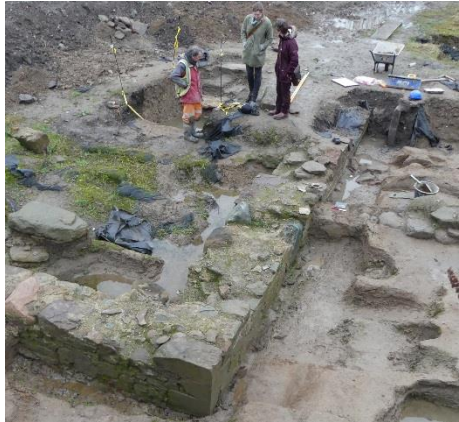
**ASSESSMENT:** This substantial complex of medieval masonry building lay just outside Perth city walls. Recent excavations have revealed clay mortared masonry wall bases, which are thought to have supported lime mortared upper walls.

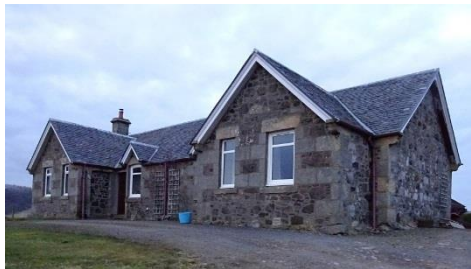
**ASSESSMENT:** The walls are of lime mortared whinstone but the foundations are clay bonded (Derek Hall). This arrangement of mortar is found in high status medieval buildings, and it is unusual to know the foundations of later dwellings, where mortars above ground are more readily identified.

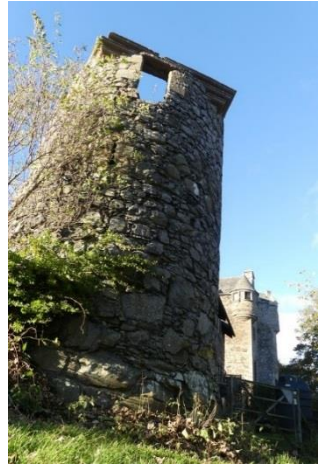
**ASSESSMENT:** The base of this tower is a vaulted oven, of clay-mortared masonry and with a clay floor. External pointing is lime and it is unclear whether other clay mortars in the castle are clay, or why clay could have been specially selected for an oven. This area is not normally accessible to the public, being adjacent to a domestic cottage.

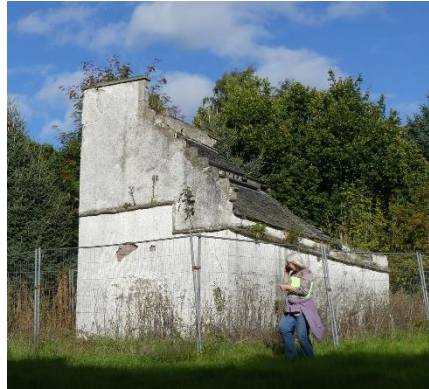
**ASSESSMENT:** The dovecot at Bonhard House is a large lectern type with harled walls of sandstone 0.8m thick in two compartments. The two skewputs on the crow stepped gables bear the date 1709. The slated roof was originally thatched. Earth mortar was reported by Steven Newsom. TM & LD confirmed clay/lime mortar.

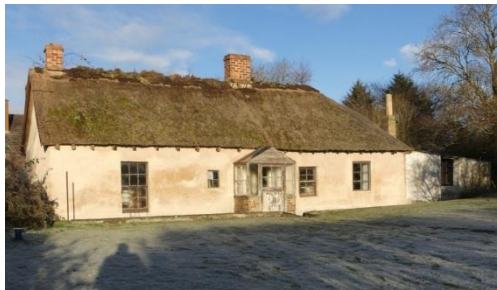
CONDITION:  Good  Fair  Poor  Ruin  AT RISK

EARTH CONSTRUCTION:  Mudwall  Clay Mortared Masonry  Daub

**ASSESSMENT:** This well-documented building is by far the best surviving example of a traditional mudwall building, with mud and stud internal partitions, wattle & daub lums and authentic thatched roof. The building has lost its original floor and has been damaged by flooding and neglect. It is not generally open to the public.

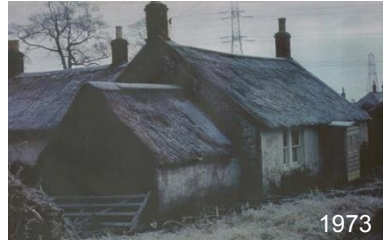
CONDITION:  Good  Fair  Poor  Ruin  AT RISK

EARTH CONSTRUCTION:  Mudwall  Clay Mortared Masonry  Daub

**ASSESSMENT:** The West Ruin was known to contain 18<sup>th</sup> century clay and straw walls attached to a larger clay-mortared rubble house. Alterations during the late 19th century, including the blocking of the rear door, the creation of a window, and the construction of a brick partition wall, which divided the house into two rooms, each with its own closet. Loss of the building's roof led to rapid decay and the remains are in active decay, though some timber elements still survive.

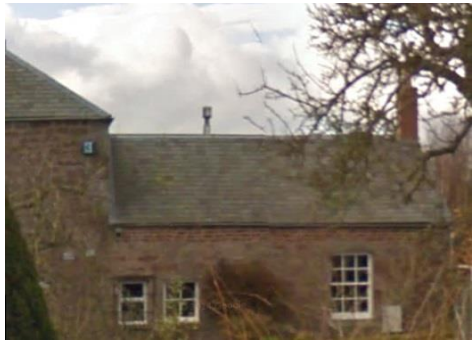
**CONDITION:**  Good  Fair  Poor  Ruin  AT RISK

**EARTH CONSTRUCTION:**  Mudwall  Clay Mortared Masonry  Daub  
 Clay Floor  Clay Plaster  Other.....

**OTHER MATERIALS:**  Thatch  Lime Harl/ Pointing  Cement Harl/ Pointing

**ASSESSMENT:** Canmore records that the east part is clay walled and once was thatched.
