CARVING A UNICORN KINFAUNS OLD PARISH CHURCH

by Michelle de Bruin, edited by Sophie
Nicol, TayLP

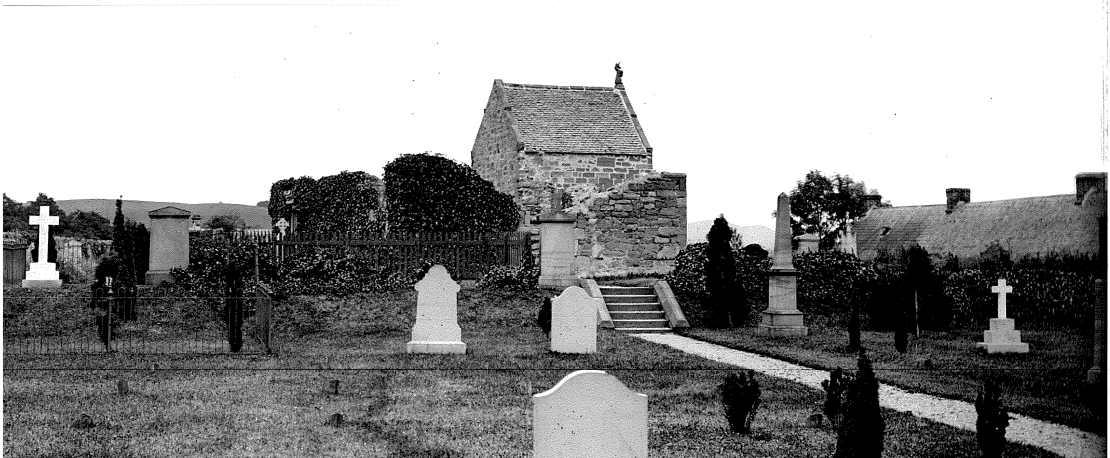
© Magnus Jackson photo

The ruins, covered in ivy, were the subject of a sensitive conservation project by a team which comprised Perth and Kinross Heritage Trust, @rchitects Scotland, and Historic Environmental Scotland, with plans to remove the ivy and consolidate the walls to prevent further damage to the ancient church. Only one part of the building remained intact – the Charteris Aisle, an addition made to the older church built in the 1500's. There was evidence from some grainy old photographs that the finial at the southern gable end had been carved in the form of a unicorn, however this had mysteriously disappeared within the last 100 years, and there was a will to reconstruct and replace it, to complete the renovation.

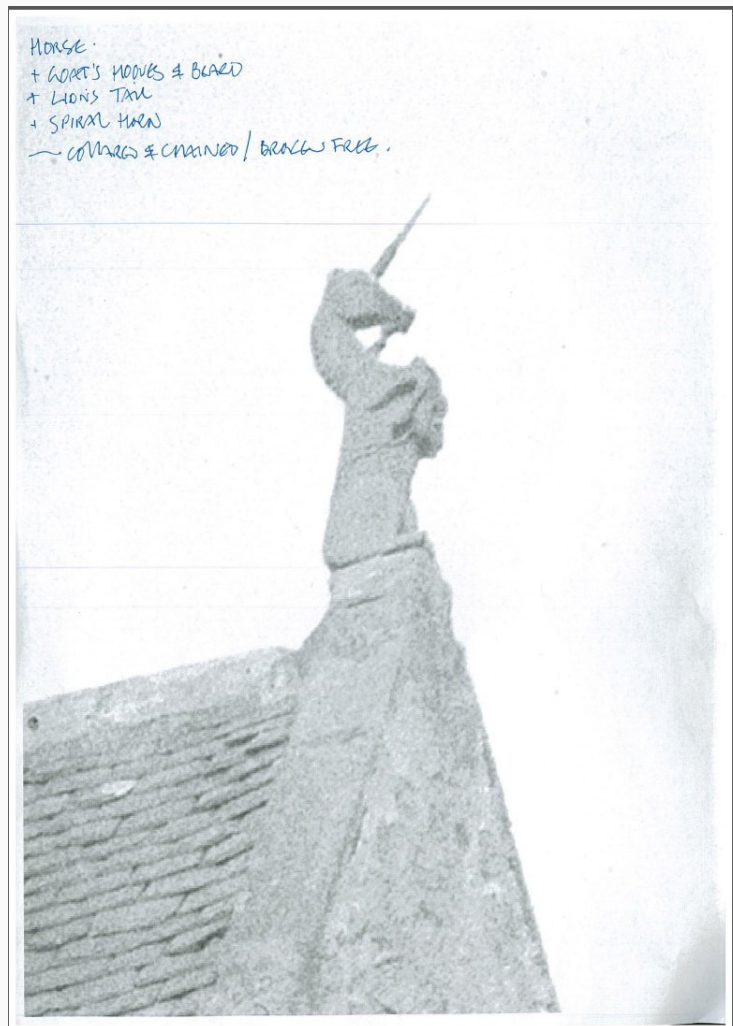
- That the unicorn was a representation of the traditional chained unicorn of Scotland
- That it was a rather naive and rusticated version – as if made by a mason rather than a carver.
- That the horn itself was clearly not part of the main body of the sculpture, and being rather long and thin, was not likely to be stone.

Taken from © Magnus Jackson photo

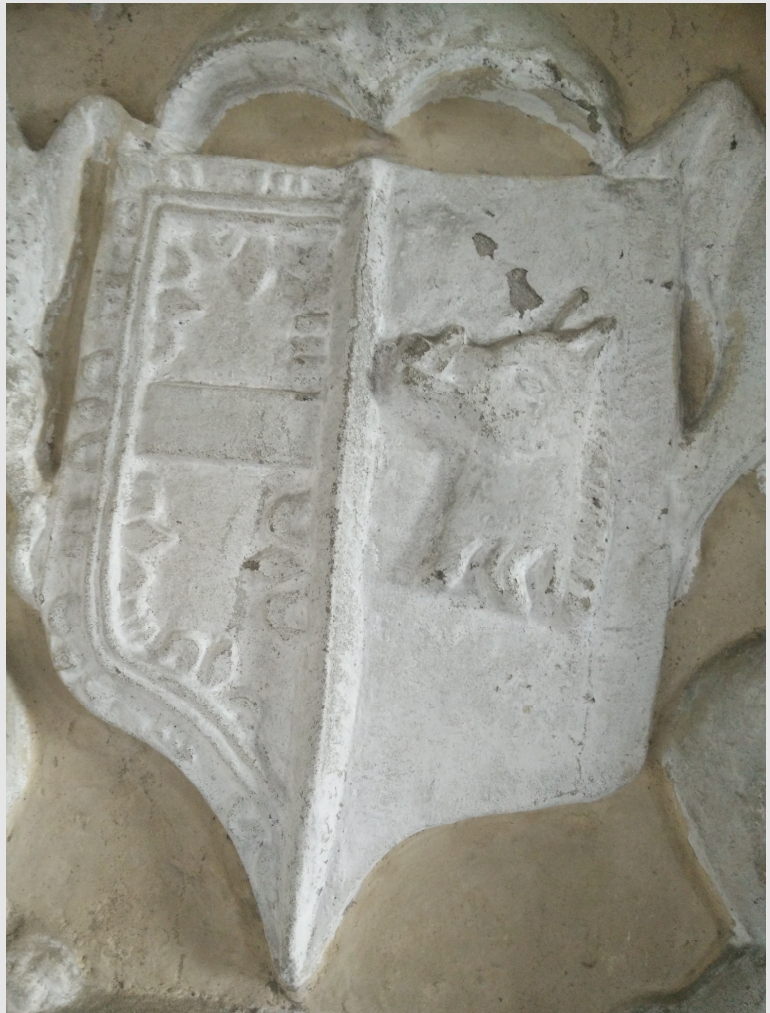
Plaster shield detail in
Aisle building interior

I met up with Sophie Nicol of Tay LP in February 2016 at the Aisle, where we examined the mausoleum. I took in some basic measurements of the stone work, in order to establish a sense of scale – to be used alongside the old pictures. We examined the stone used on the building so that I would be able to find a match for the original, I also collected some samples. In order to help with artistic interpretation, we went into the mausoleum and examined and recorded the carvings existing internally for the Charteris and Chisholm families. These comprised some rather rusticated, but lively family crests, which we paid close attention to because the unicorn finial bears a shield for which there is no indication of content.

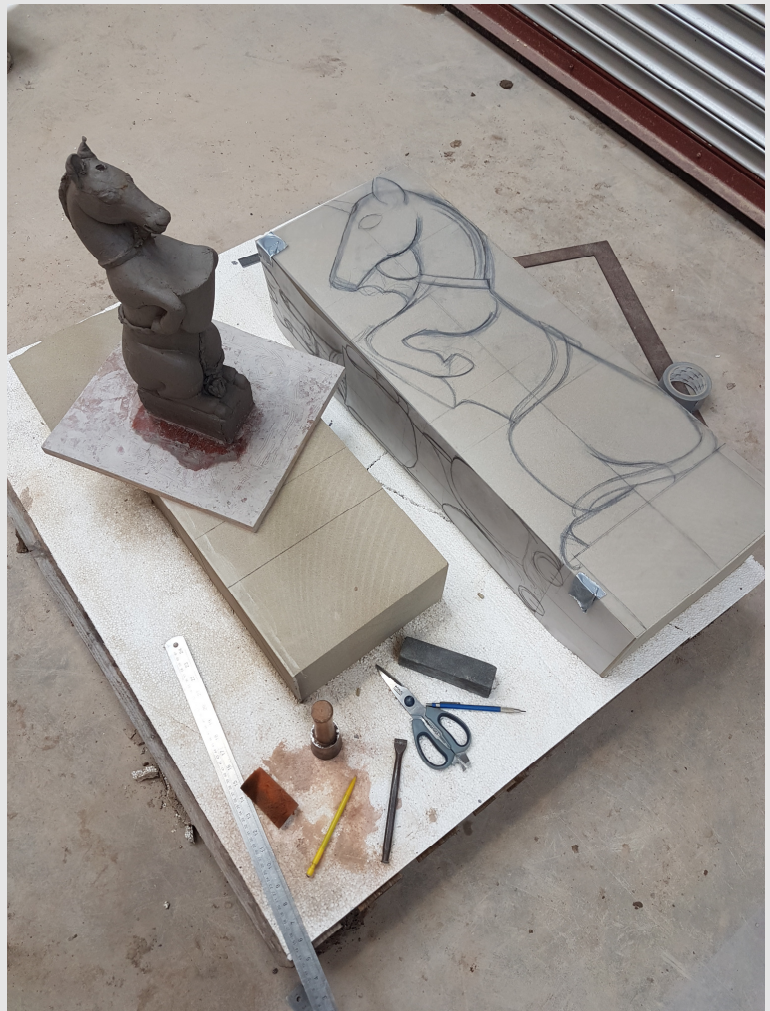
Scale Clay model and stone block.

Following a few preliminary drawings, it became apparent that the best way to move the reconstruction forward would be to make a model, as indeed would be necessary for the carving. So I made a model in clay which could be used eventually for scaling up for the carving. It was an interesting experience making the model, since my own instincts to follow some basic knowledge of horse anatomy had to be repressed somewhat, every time I referred back to the original photograph.

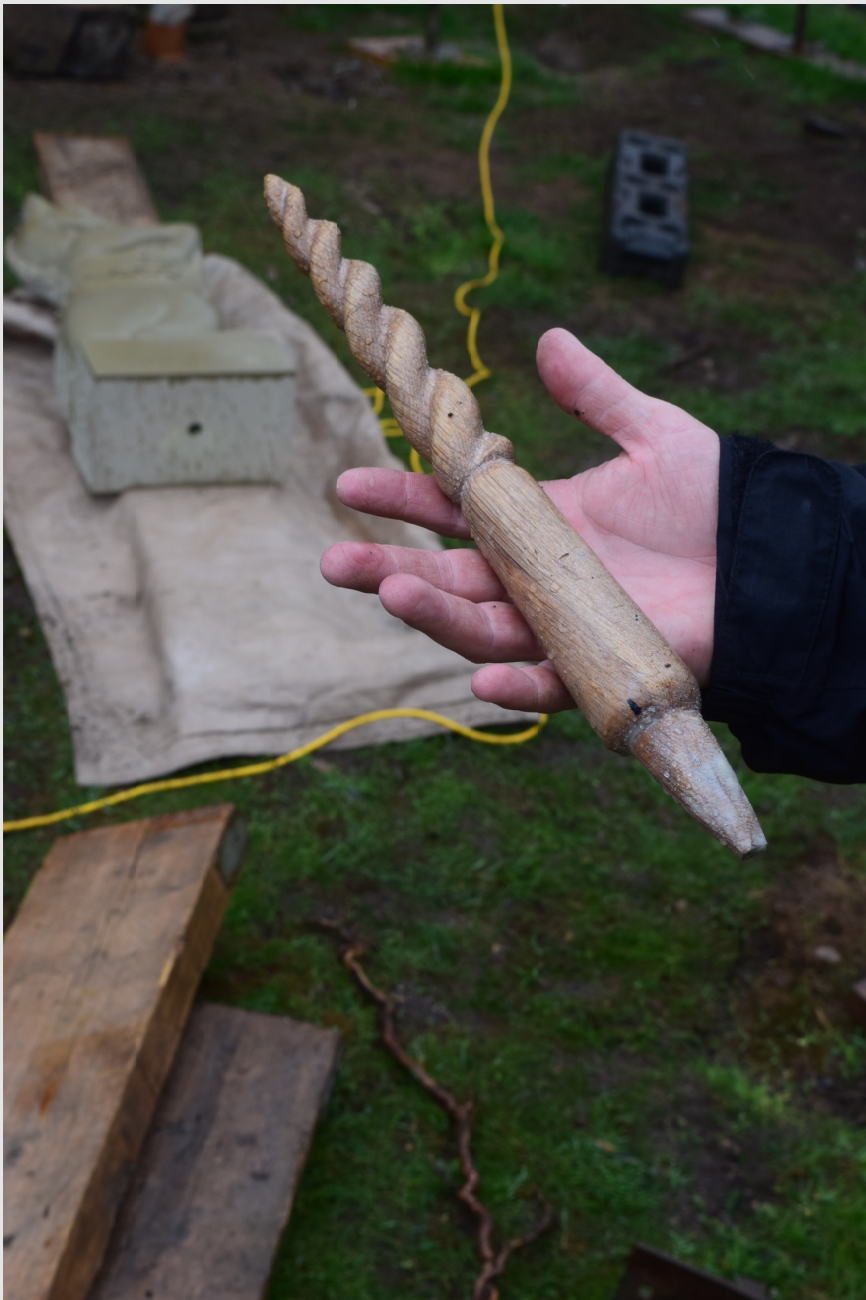
The only question which remained unresolved was the question of the horn. It was decided that there was some precedence for wood, and in some ways, it seemed a practical option too. Unlike a metal, there would be no staining down the stone, also, that a hard wood like a well seasoned piece of oak, would last for many years, be easy to remove or replace, and is relatively inexpensive to do. I was certainly very happy to get my wood carving chisels out!

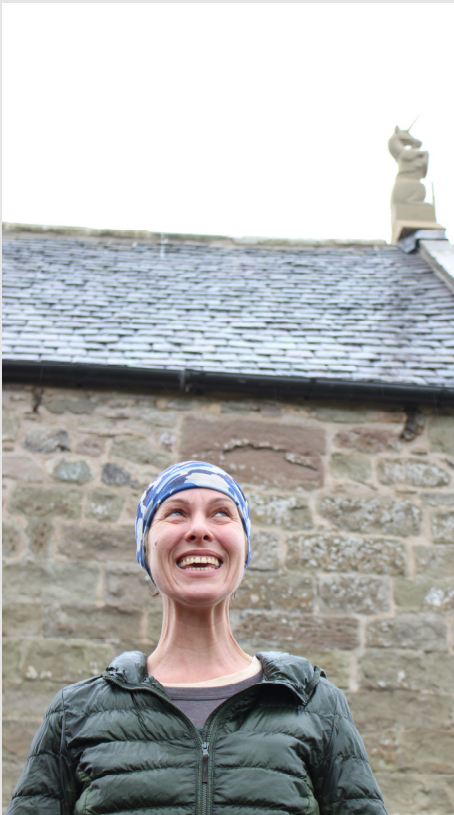
Stonecarver Michelle De Bruin at the installation of the unicorn at Kinfauns.

The unicorn was finally taken up to Kinfauns in May 2017, and successfully installed on top of the Aisle by the contractors. I rushed to see it from the angle of the original picture, and I am sure that the proportions are good. The detail is harder to agree on because the question is never decisive when restoring something so old, or undocumented. The will to preserve it is the main defining factor in the reconstruction. The spirit of the unicorn is restored.
